## INVENTORY FORM FOR STATE HISTORIC SITES SURVEY

Parson Green Farm  
AND/OR COMMON**2 LOCATION**

QA-234

Orlando Ridout V, Historic Sites Surveyor

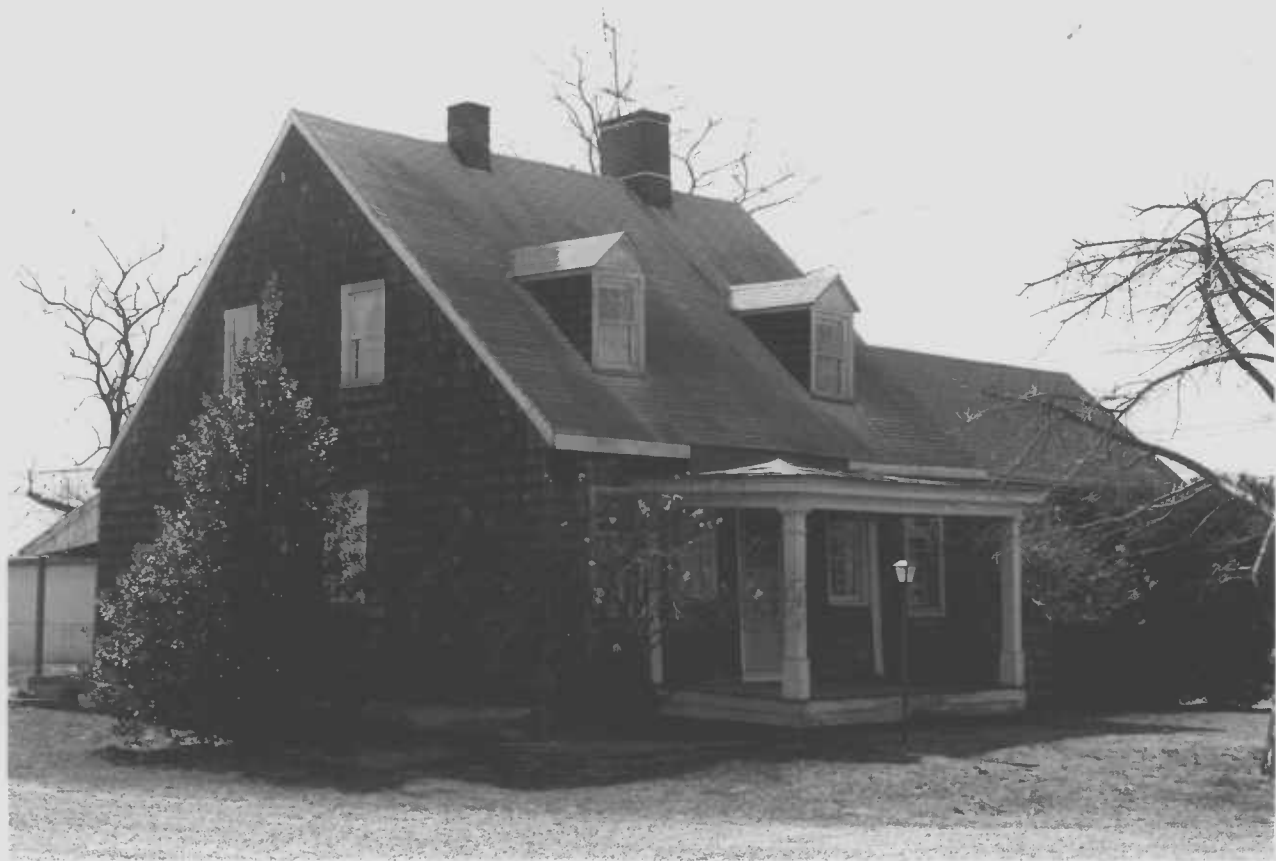
Parson Green Farm  
Church Hill vicinity  
Orlando Ridout V 1981  
Front facade from East

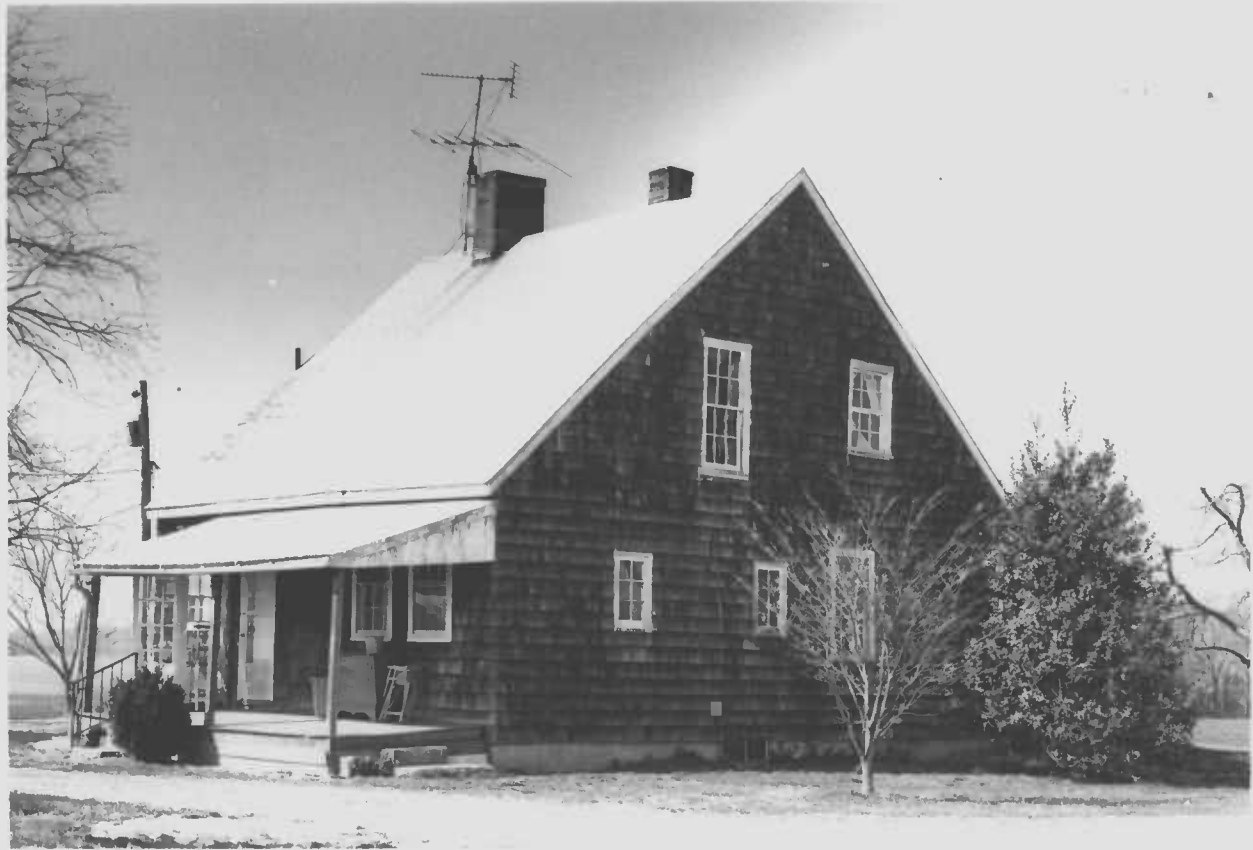
QA-234 Parson Green Farm  
Church Hill vicinity  
Orlando Ridout V, 1981  
View from South
